Measurement and Verification Retro-Commissioning of Commercial Buildings

**40th Annual Florida Plans and Construction
Seminar and Expo**

Orlando, Florida
October 1, 2024

Travis County Medical Examiners Office

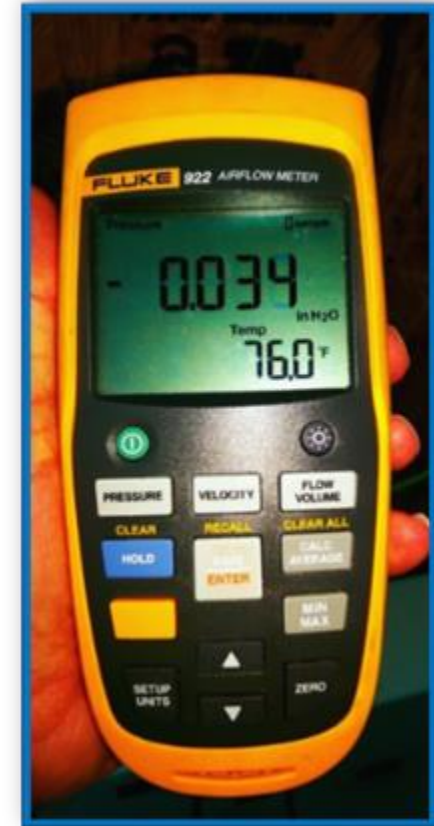
- Measured and recorded building indoor air pressures, floor to floor differential pressures, and corridors to Morgue and Autopsy rooms using digital manometer.

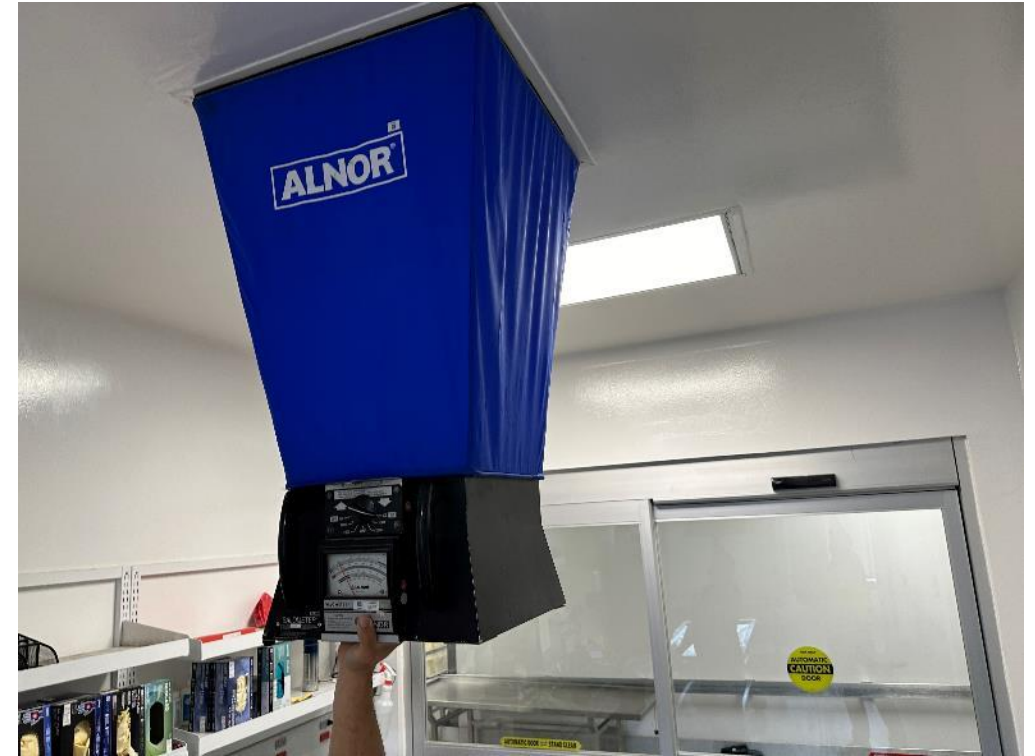
- Digital flow hoods were used to determine supply and return CFM rates at air grilles versus design
- Digital flow hoods were also used to determine exhaust CFM rates at air grilles and exhaust hoods versus design

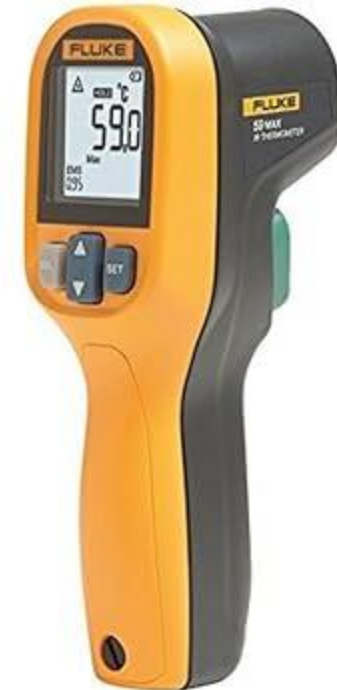
- Obtained temperature and relative humidity measurements at varying periods of a 24-hour day
- Placed temperature and relative humidity recorders in strategic places for 5-day continuous recordings and graphing

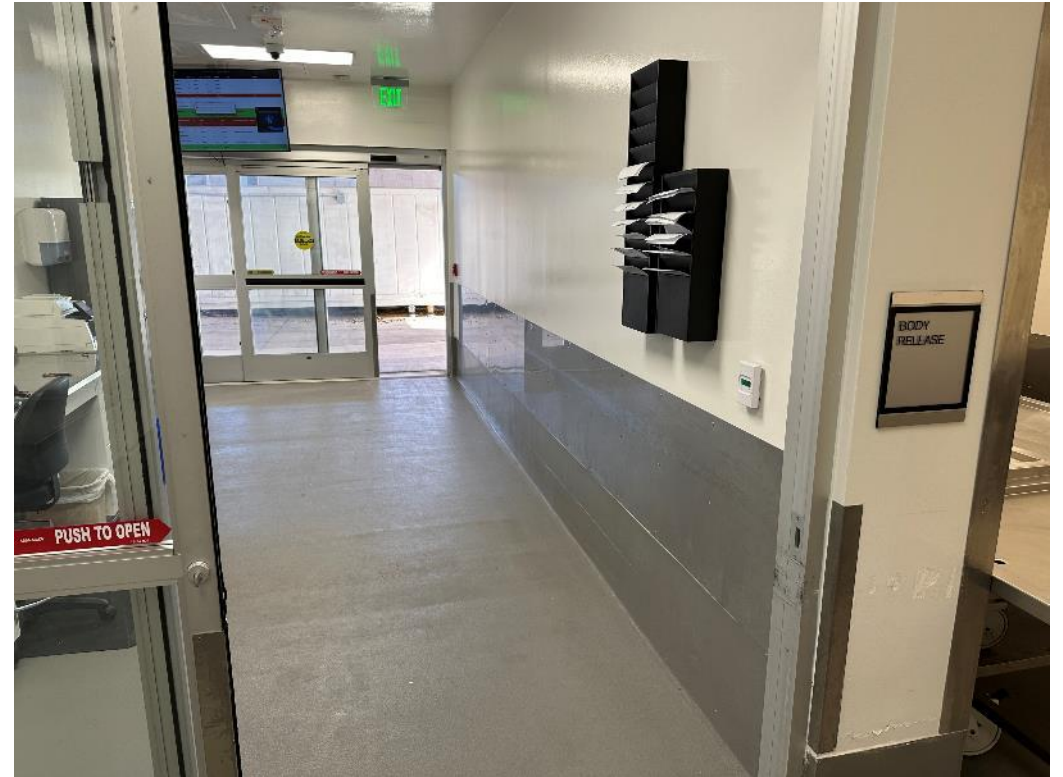
- Conducted observations of air tightness of operation at sliding door vestibules during typical 24-hour days

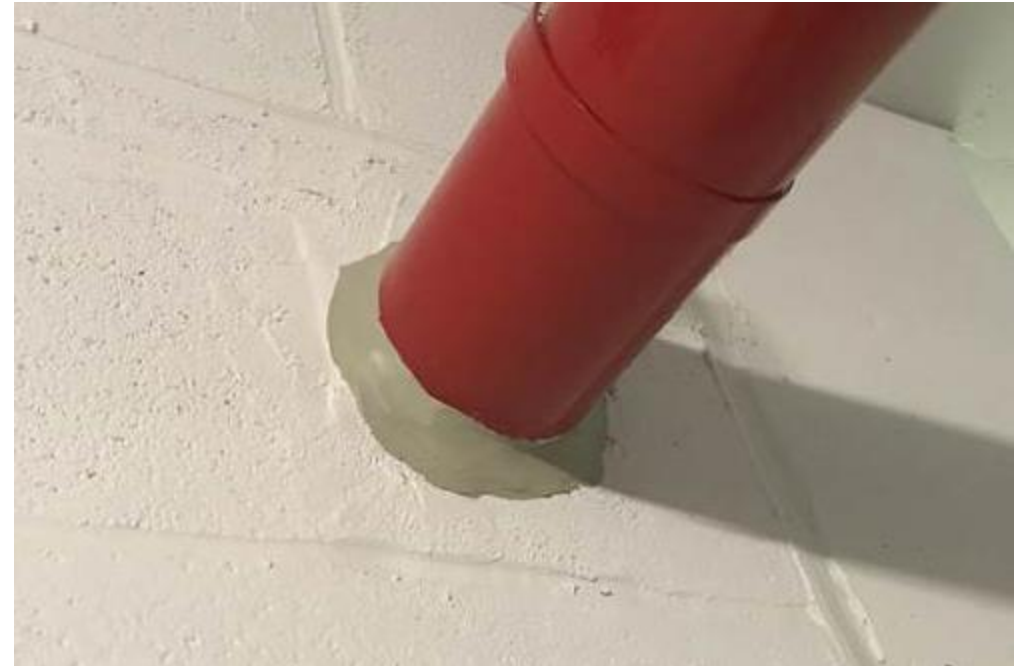
- Conducted observations of integrity of floor, wall, transfer ducts, and air grille sealants

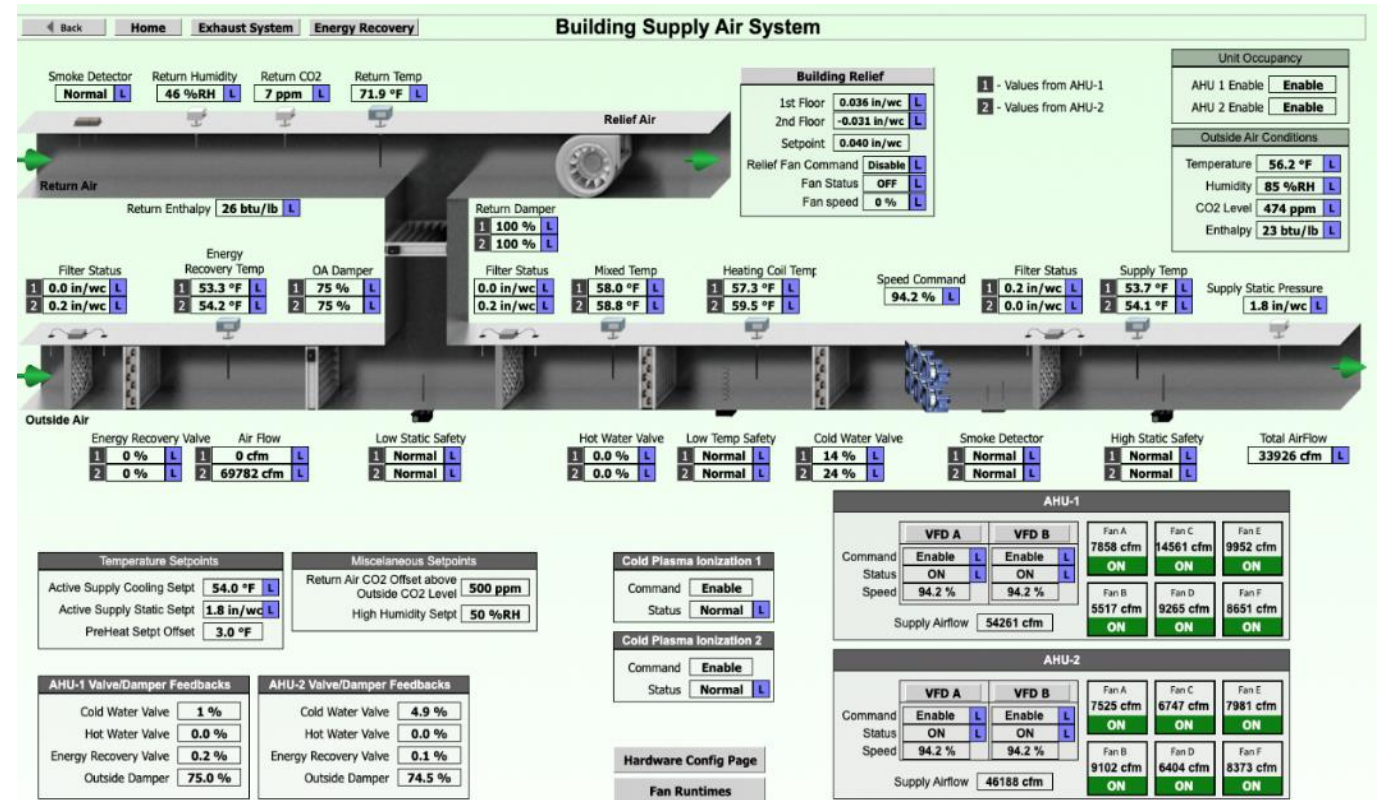
- Building automation system was used to track and trend HVAC system

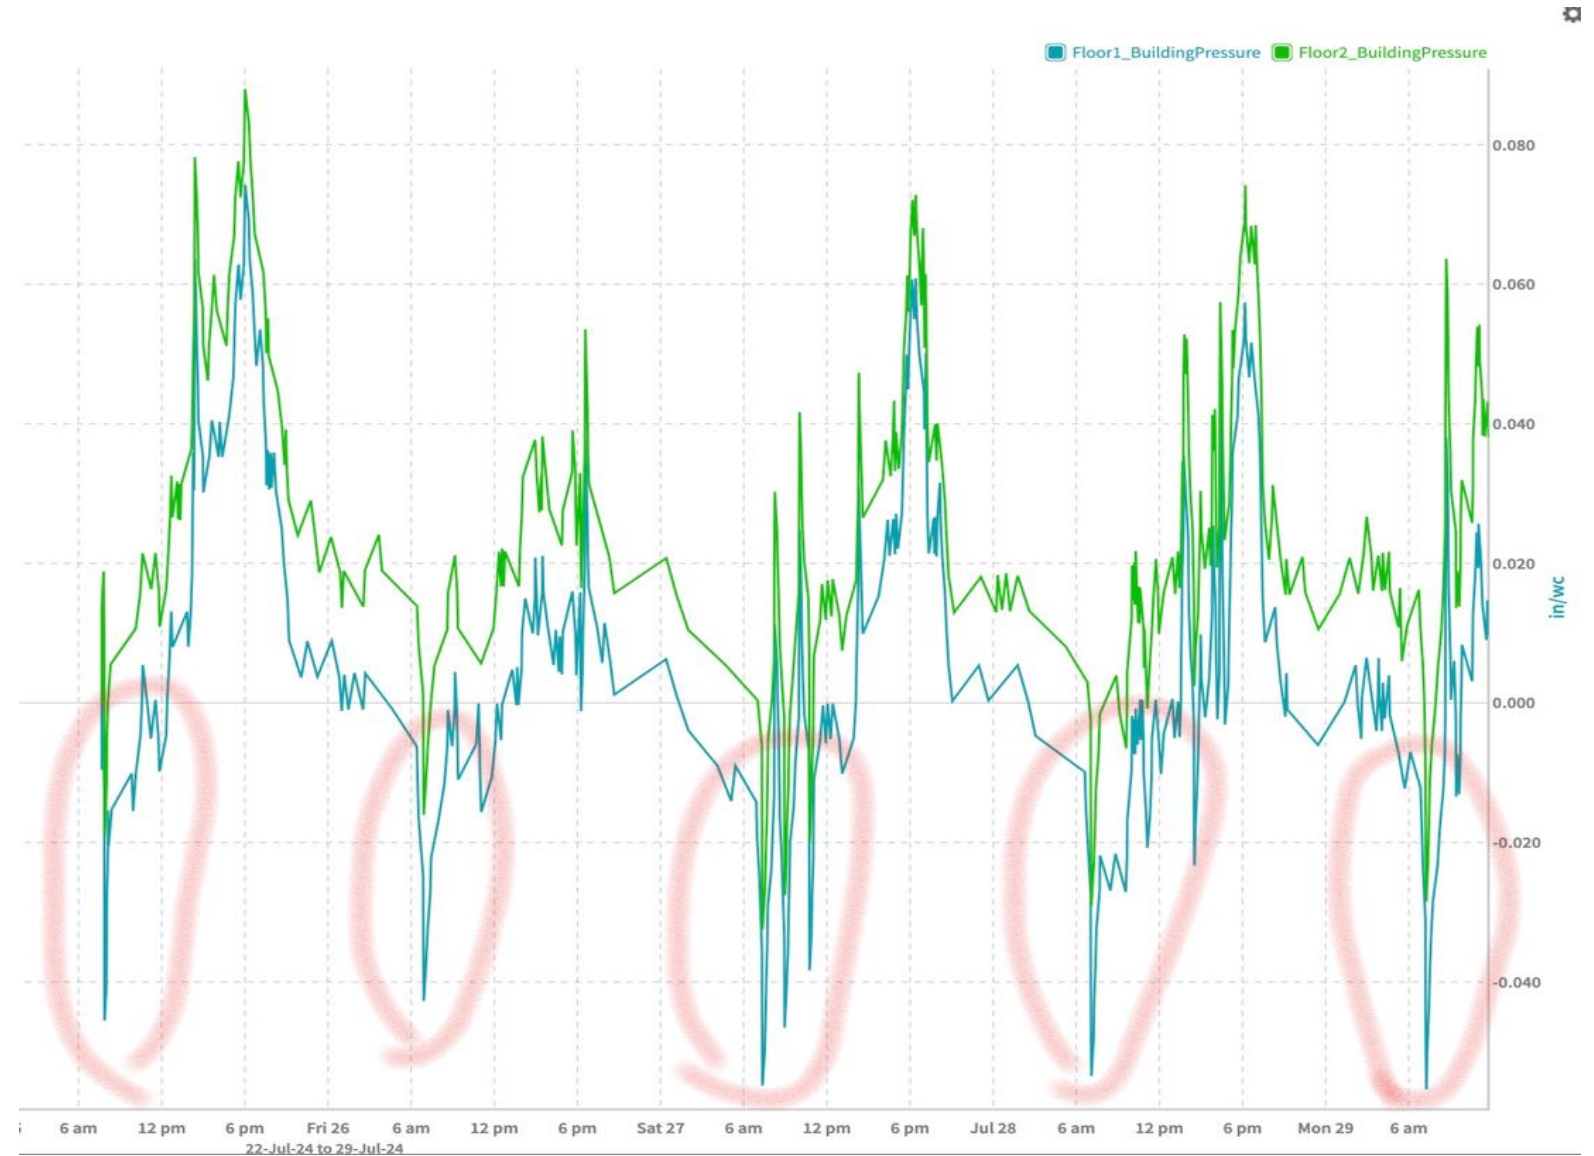
Issue	Findings	Resolution
Openings found between morgue and adjacent spaces not well sealed, allowing odor migration due to differential pressures	Numerous pipe, duct, conduit floor to floor penetrations not sealed Duct leakage observed in exhaust, return, and supply duct was repaired	Pressure induced smoke test performed to identify leaks in enclosure and ducts Structural and ductwork openings sealed

Floor by floor
variations in measured
building air pressures
with digital
manometers

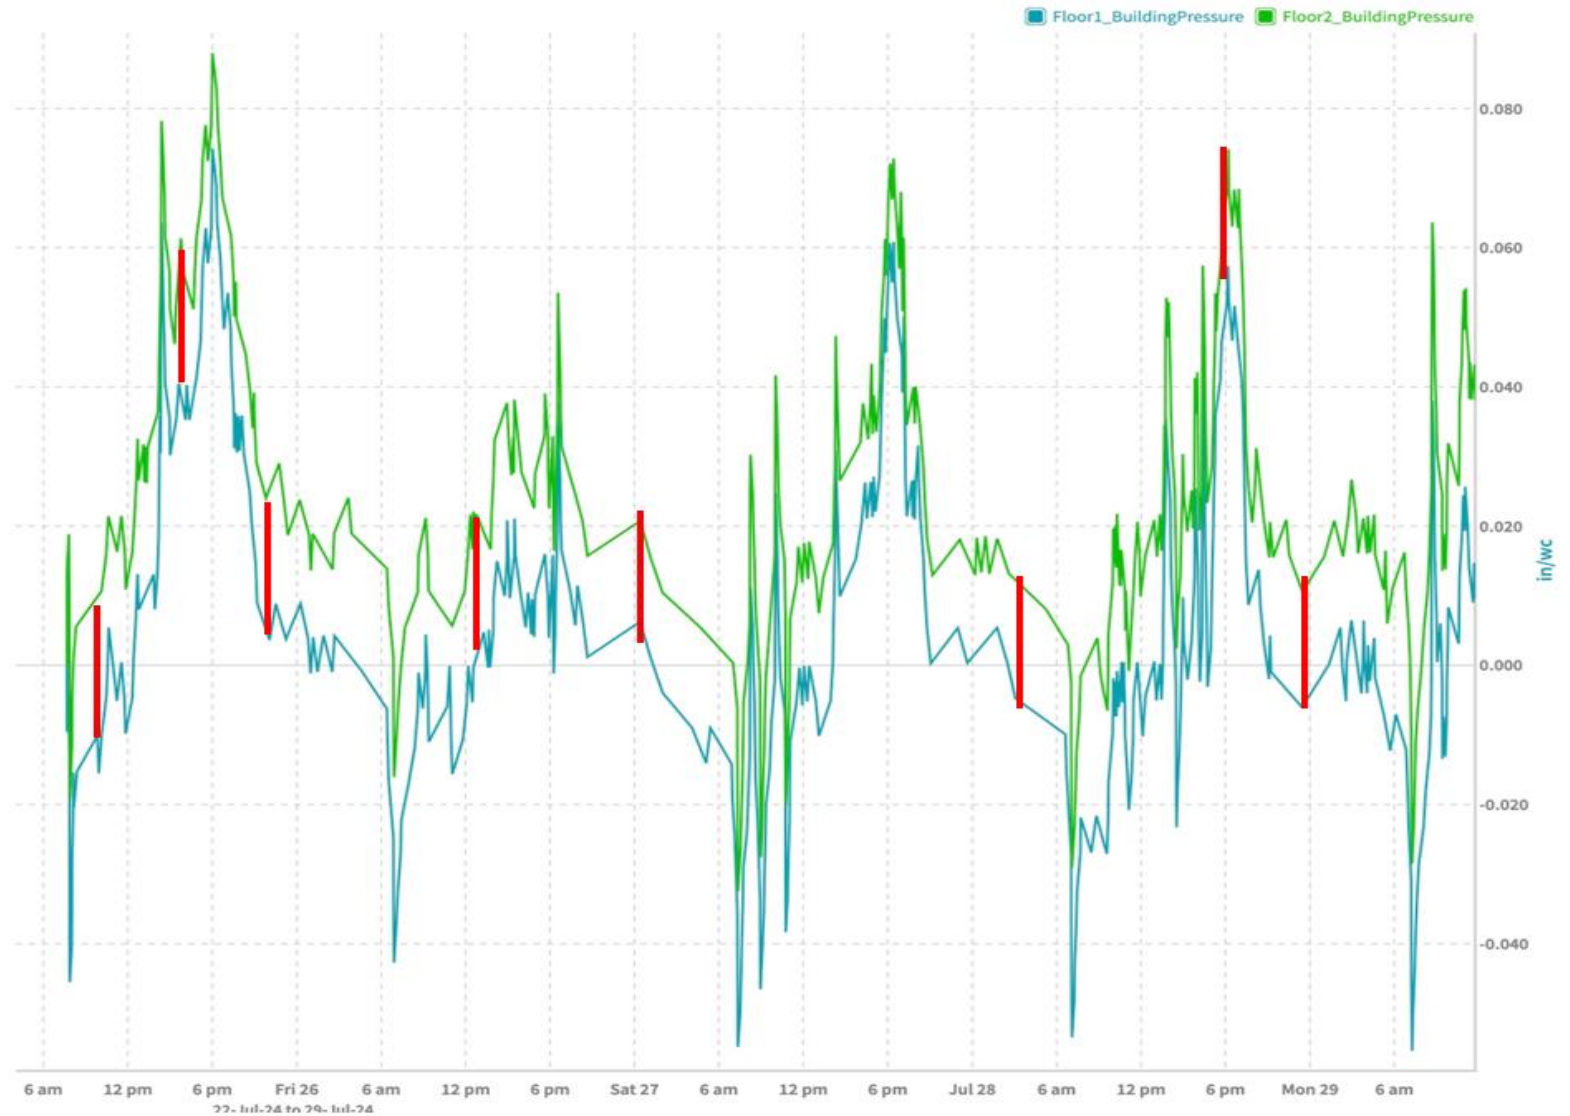
Differences in differential air pressures in red between floors at critical periods during a typical day

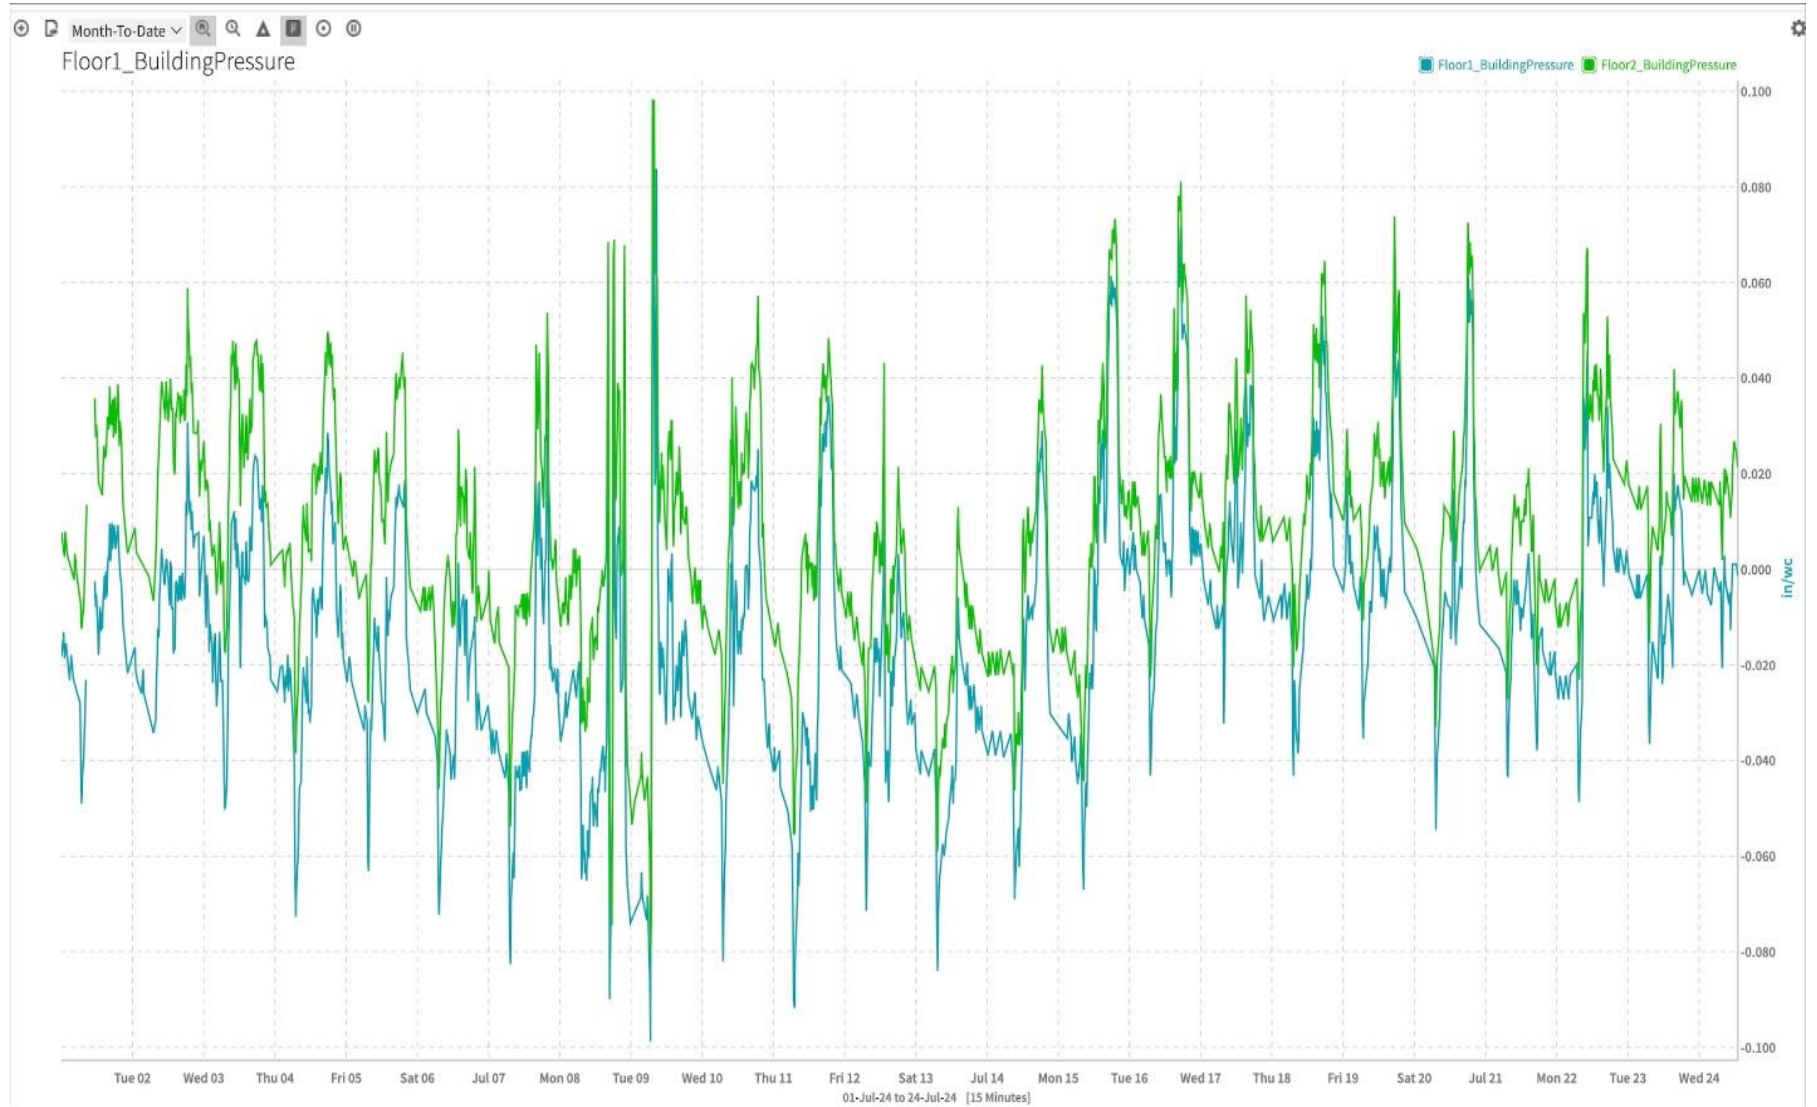
Extensive
cycling of air
pressure on
floors during
typical day

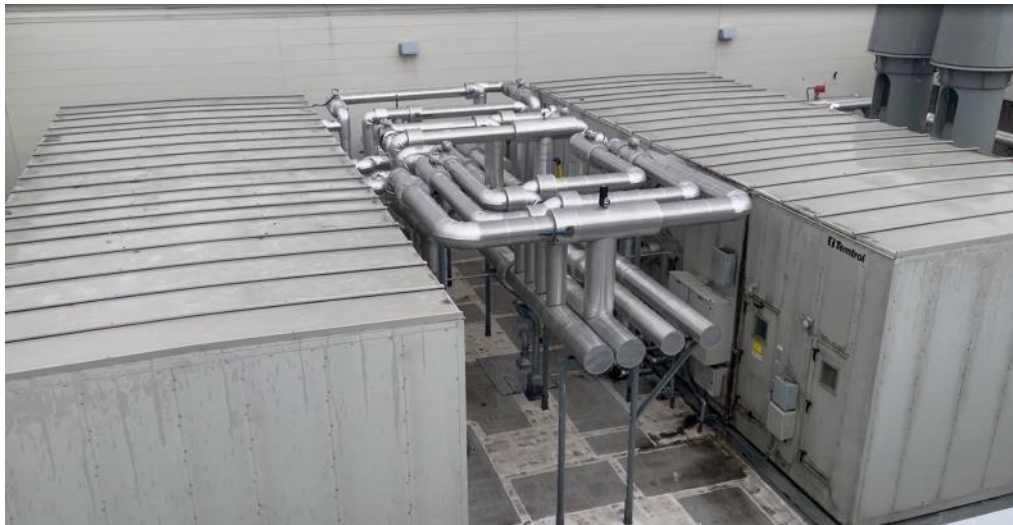
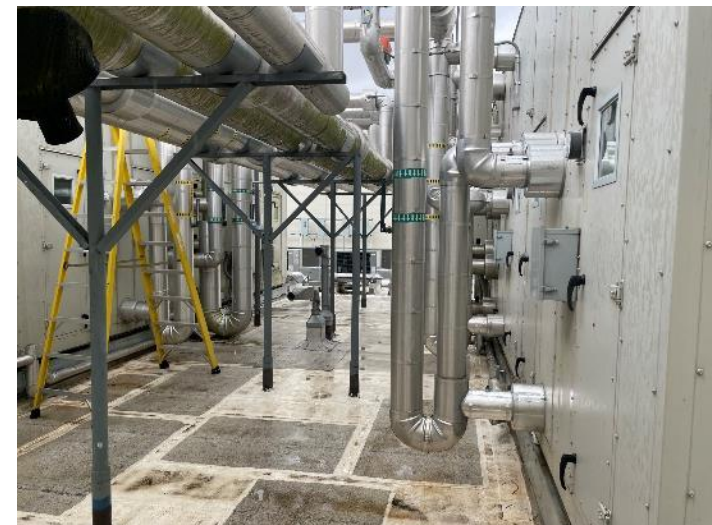
Issue	Findings	Resolution
Inconsistent air handling unit supply air temperatures	Seized chilled water valve Widely fluctuating air handling unit supply air temperature	Repaired and calibrated chilled water valve Water chiller controls recalibrated

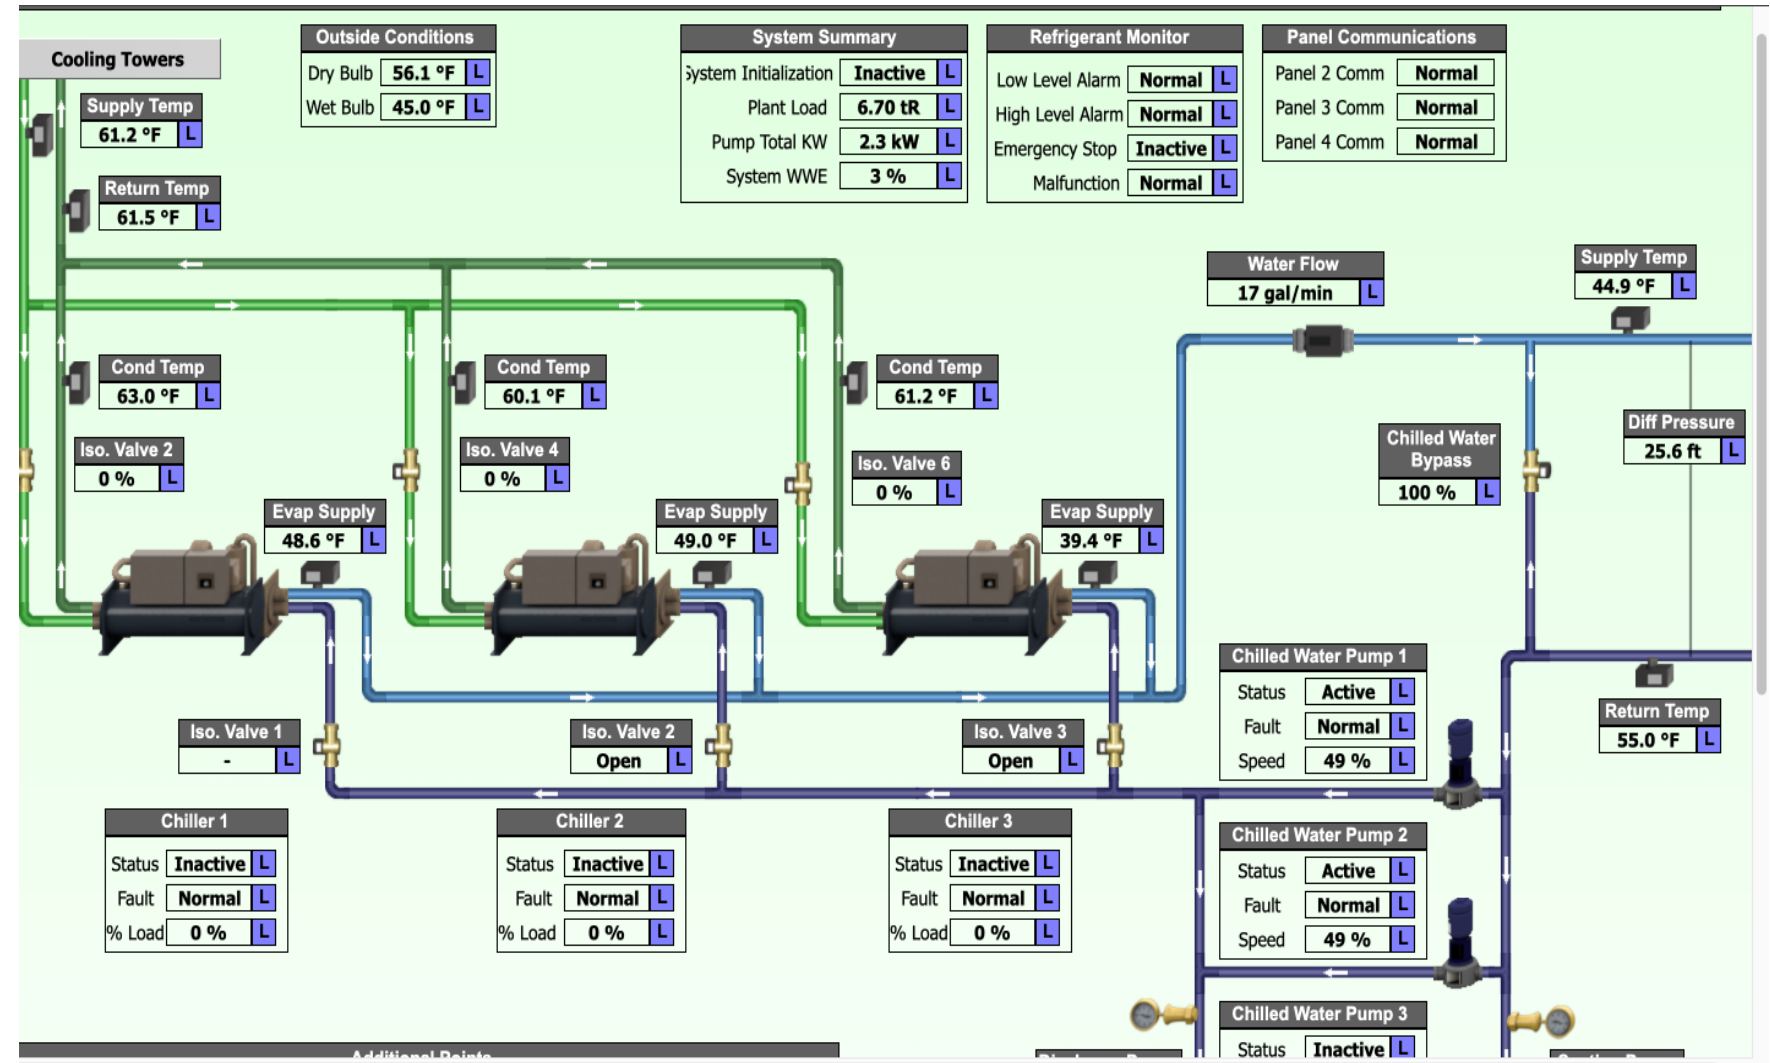
Issue	Findings	Resolution
Chillers not loading properly, cycling second chiller on/off every 15-min, cycling off after 15-min	Excessive scale on turbine/impeller type flow meter Meter reading inaccuracies causing problems with chiller staging	Removing, cleaning, and calibrating flowmeter

Chiller schematic
with chillers
inactive at 56.1 °F
outside air
temperature and
two chilled water
pumps operating

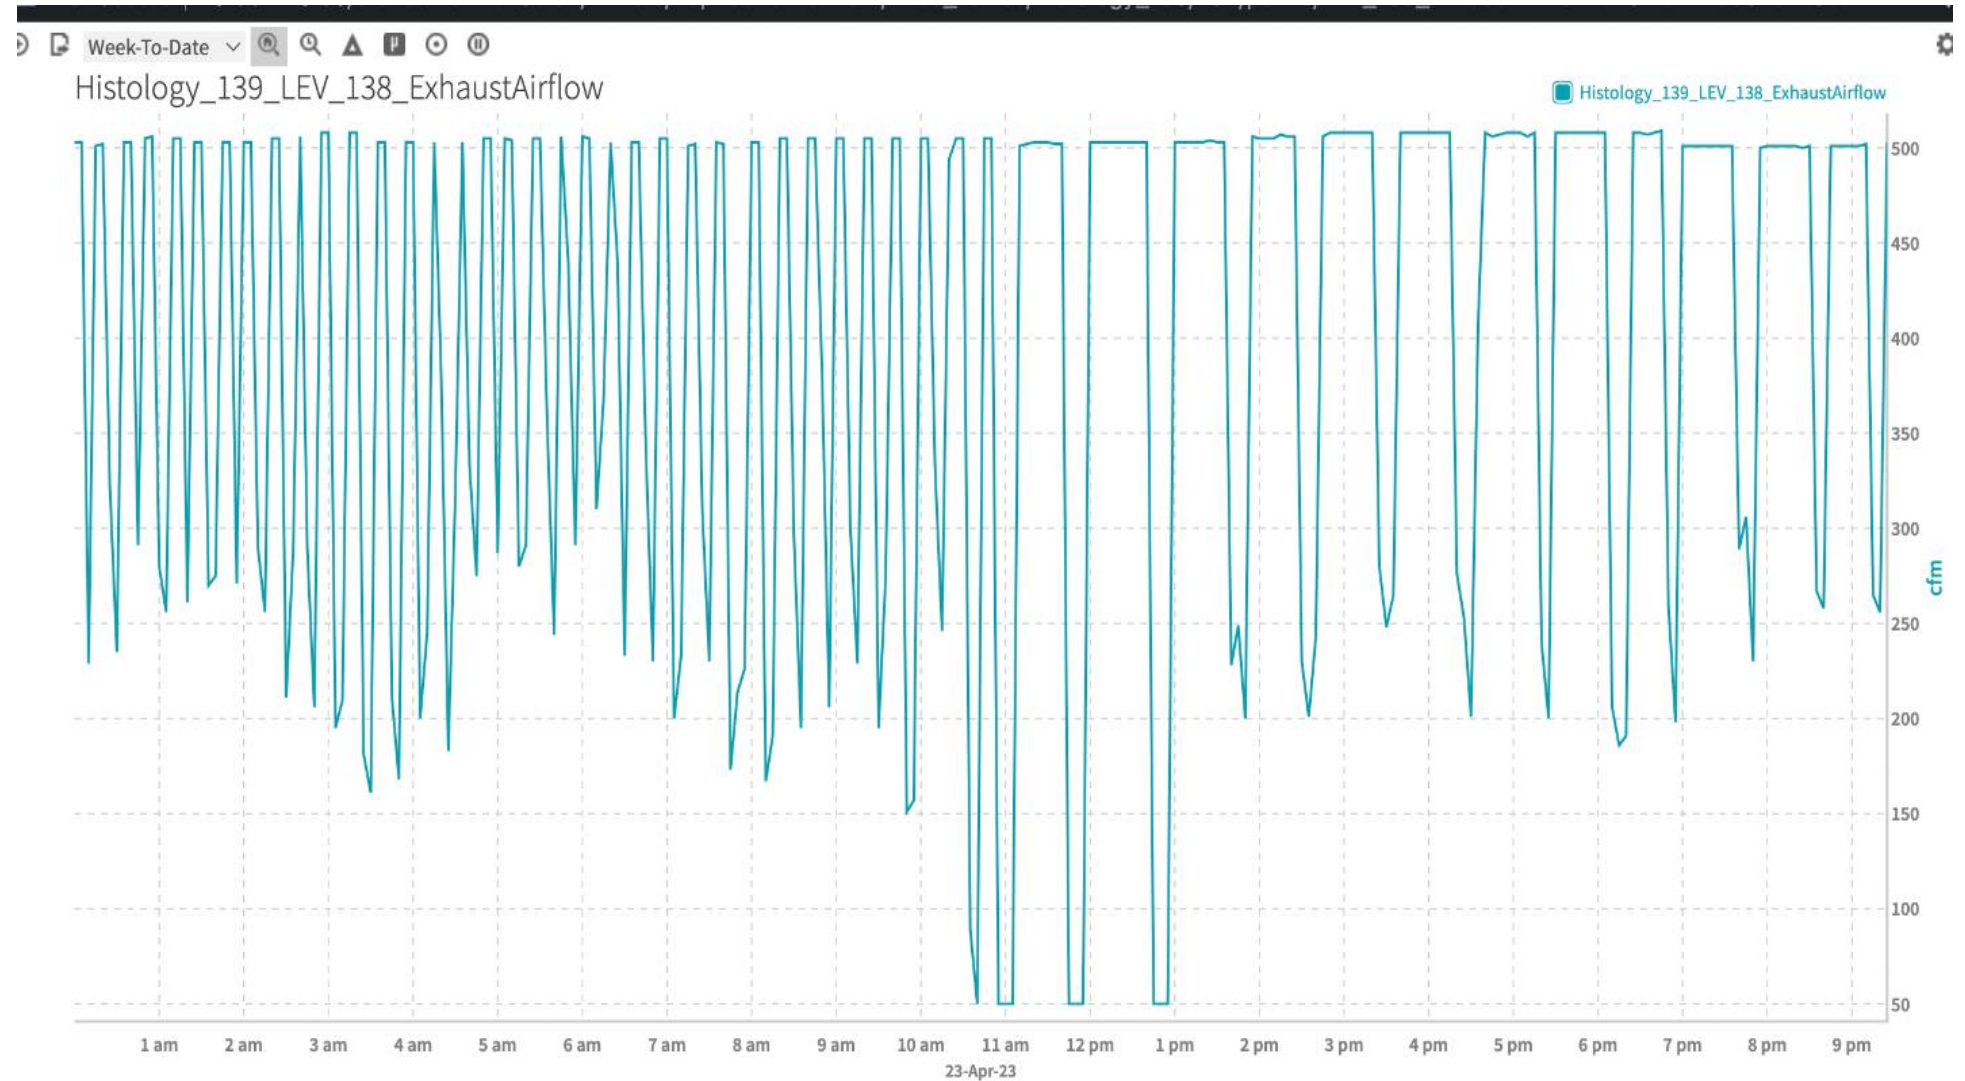
Variations
in exhaust
air flow
during
typical day

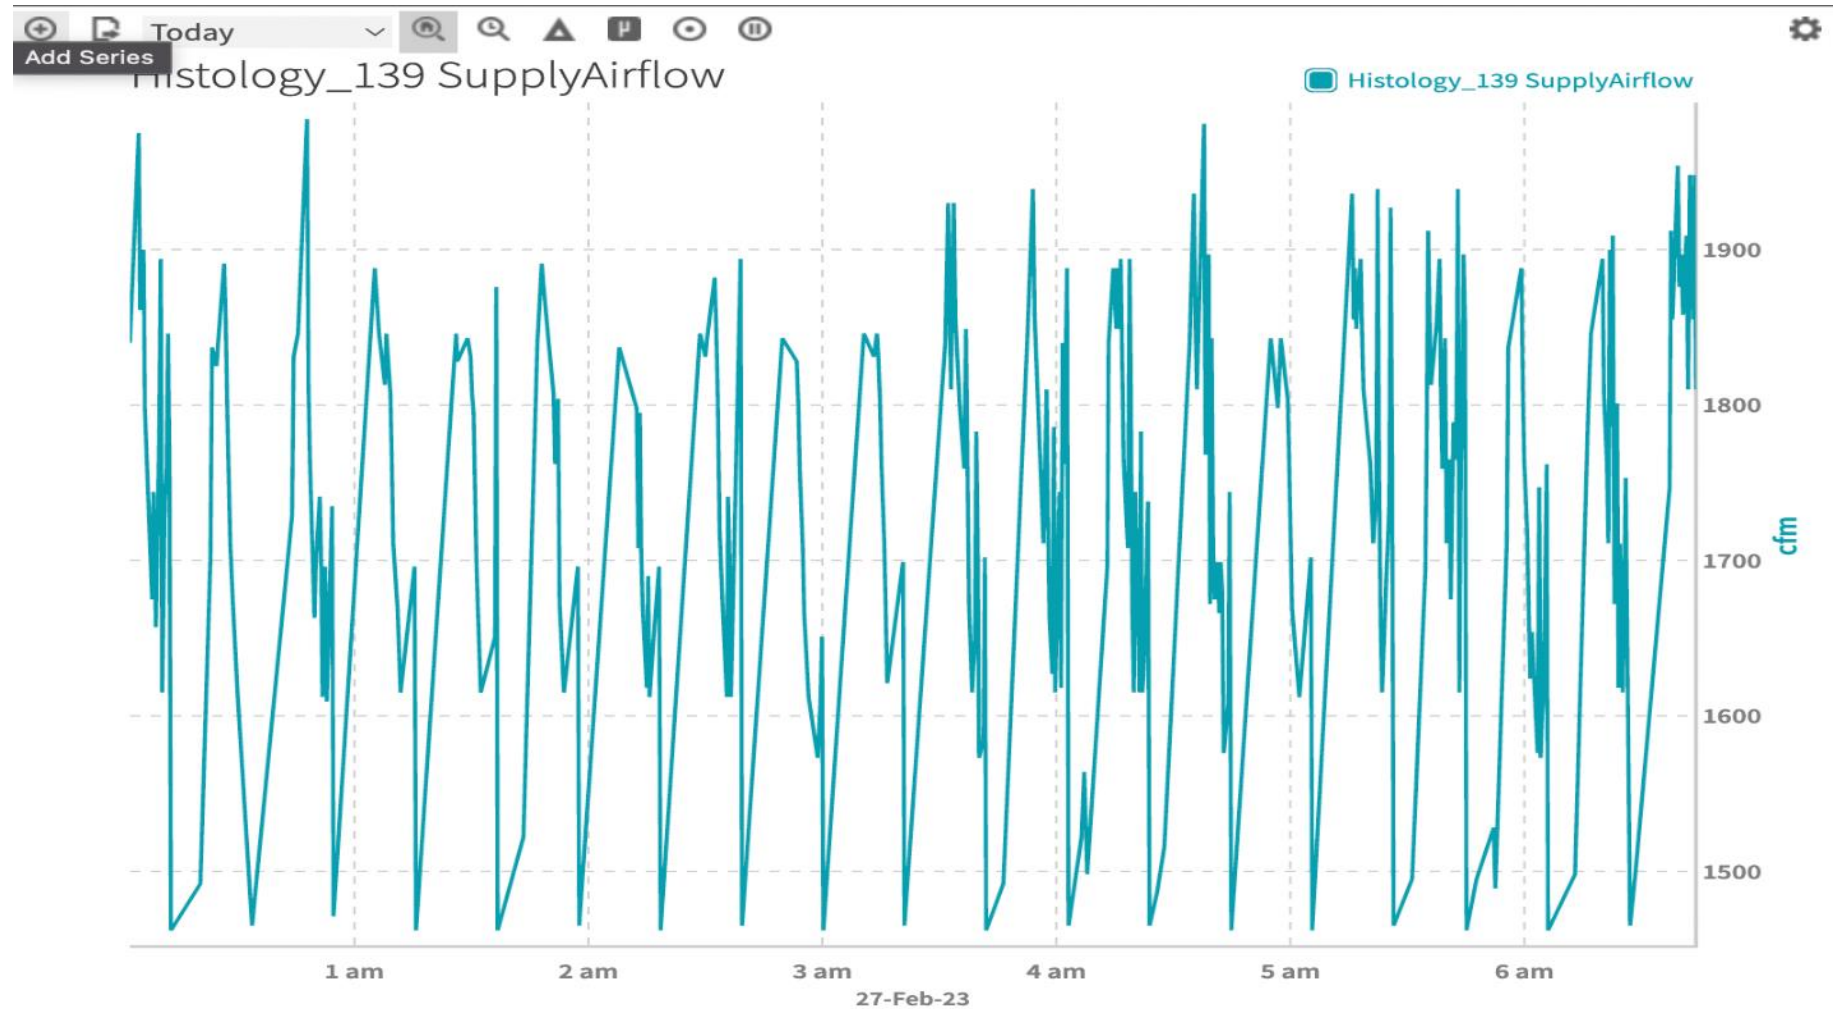
Variations
in supply
air flow to
room 139
during
typical day

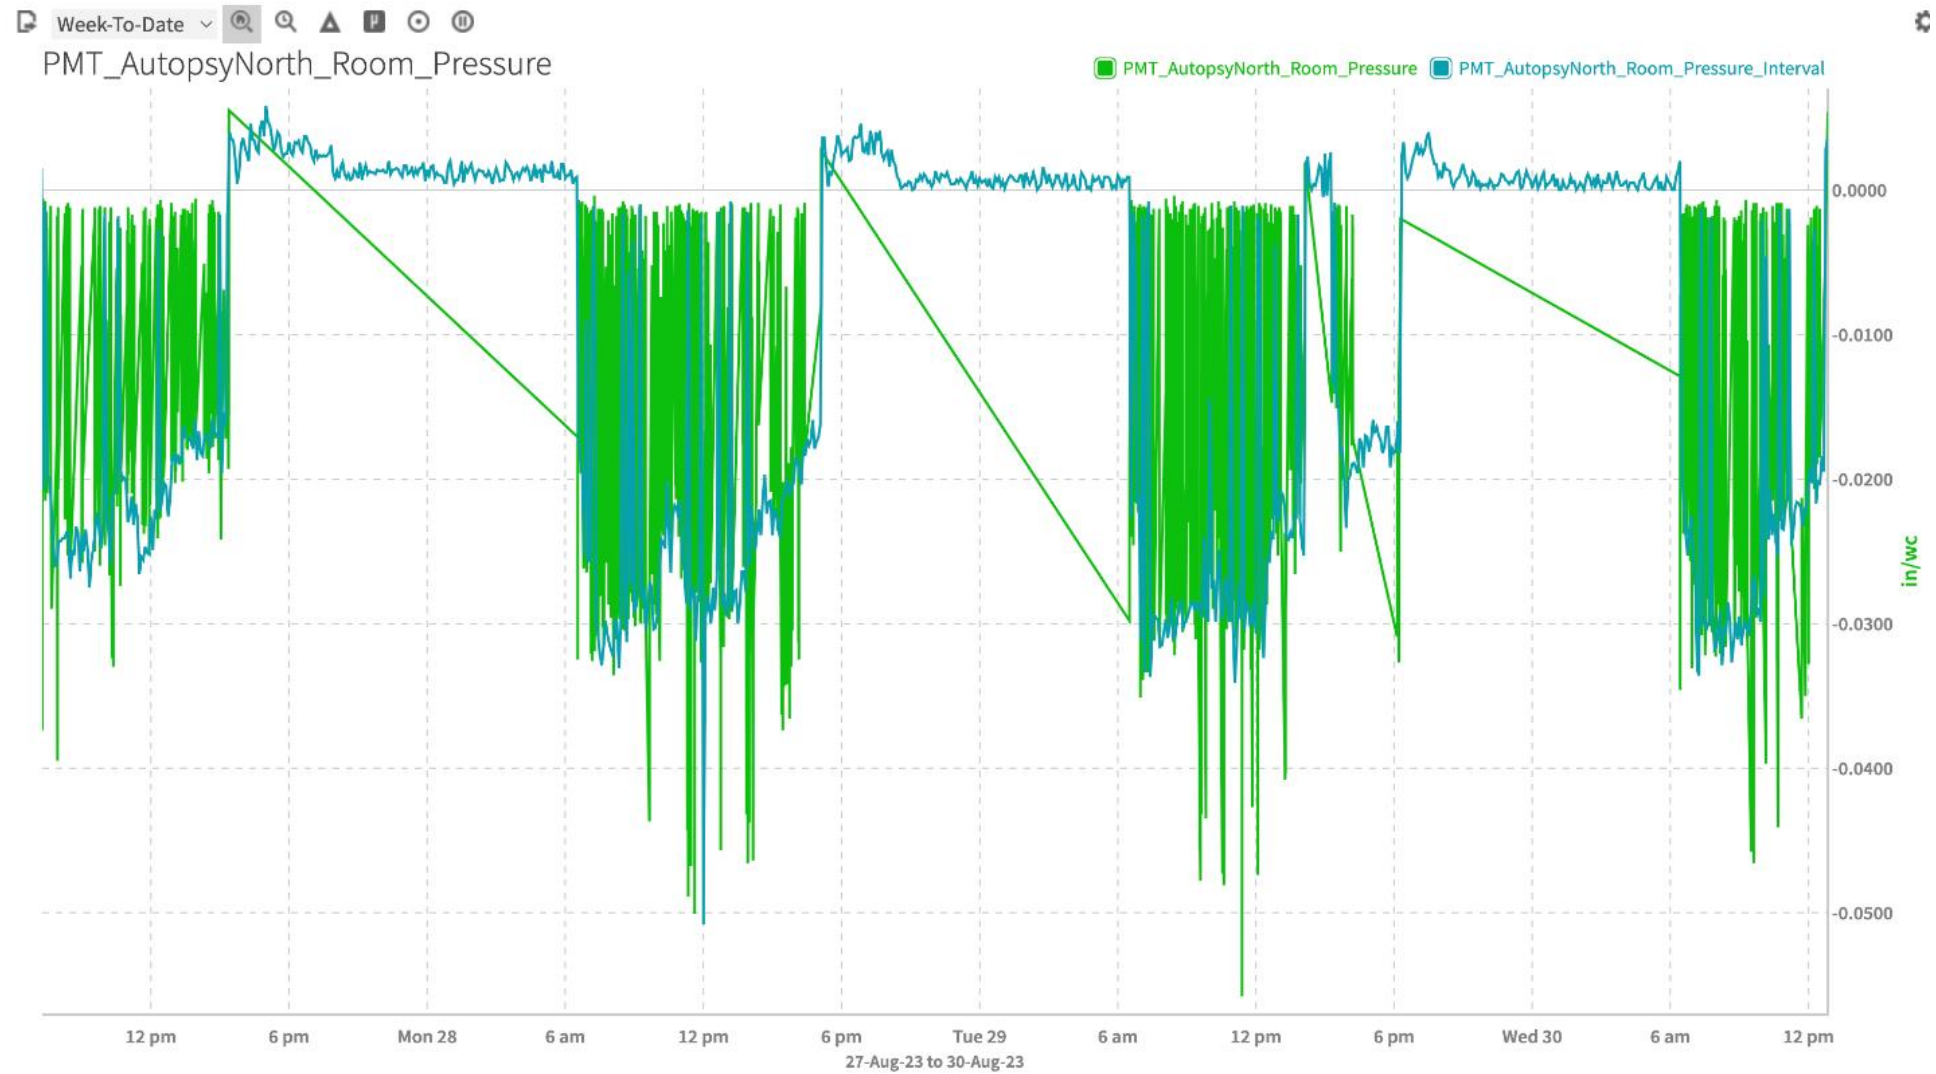
Issue	Findings	Resolution
Autopsy room differential pressures relative to adjacent space fluctuated between occupied hours with higher exhaust flow requirements and lower exhaust flows when generally unoccupied	One actuator on supply air valve found faulty and was replaced.	Calibrated VAV terminal box supply air valves supplying autopsy room

Wide
variations
in autopsy
room
indoor air
pressures

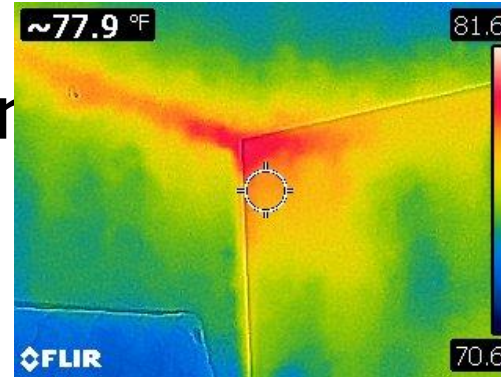
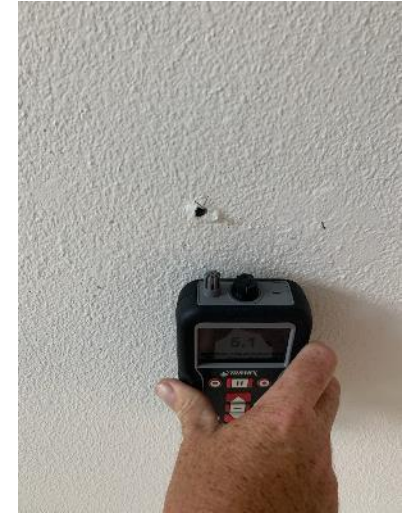
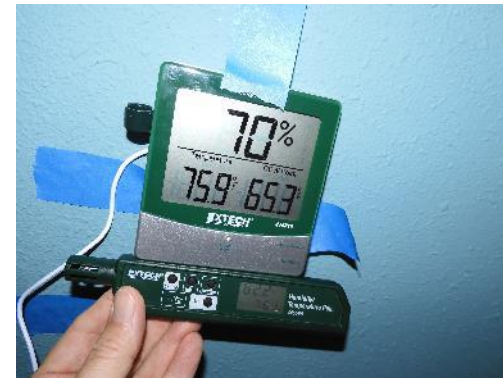
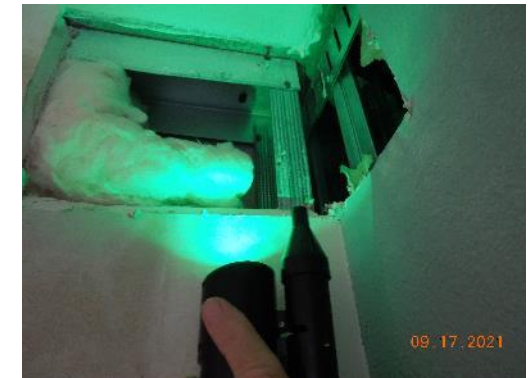
- IR/moisture meter dew point surveys of interior of exterior walls, roof and hollow core floor panels
- Smoke testing of wall cavities
- Test cuts in roof and walls assemblies to confirm construction/pathways
- Sealant testing
