Lessons Learned from Pharmacy Cleanroom Renovations

Tony Martin, PE

Director, Healthcare Commissioning

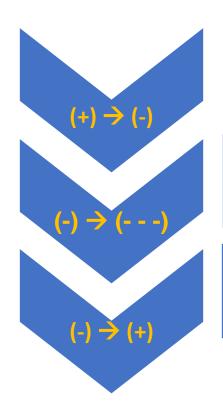
Differential Air Pressure Reversals

• Entry of viable contaminants (e.g., bacteria, fungus) into positively pressurized cleanroom

Ingress of viable contaminants into overly negative space

• Release of hazardous agents, materials from negatively pressurized cleanroom, occupational exposure

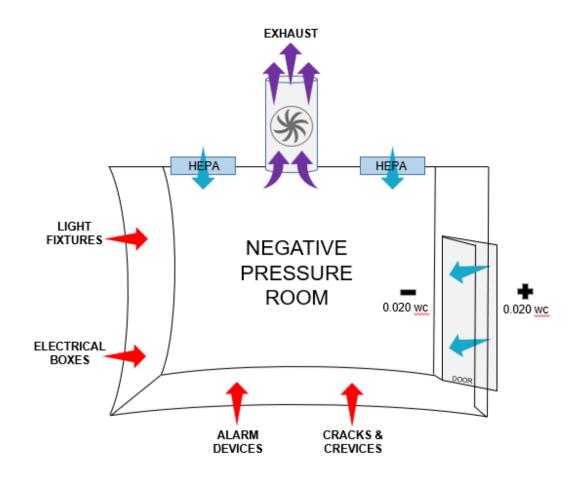
Differential Air Pressure Excursions

- Improper equipment selection, undersized AHU, airflow design
- DP is affected by primary air originating from AHU

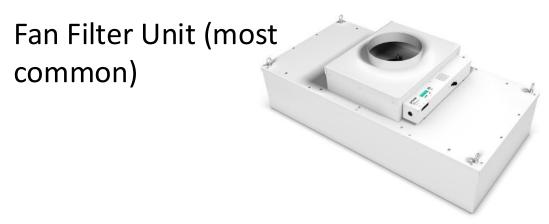
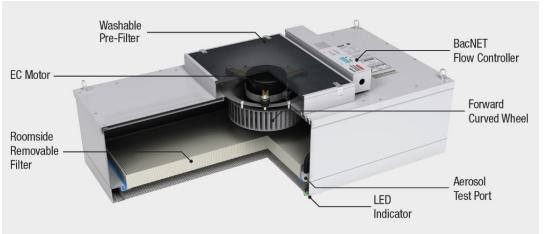
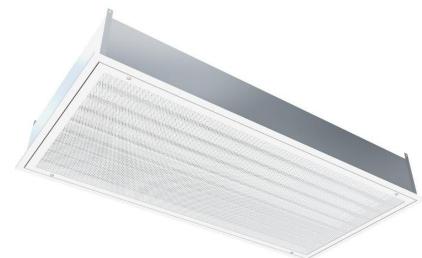
Impact of Equipment Selection on DP

No fan, all airflow will be from Air Handling Unit

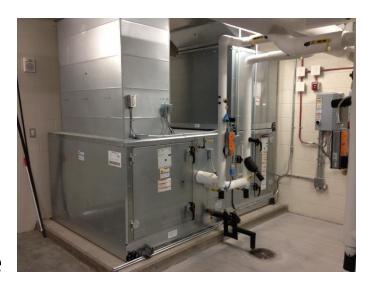
Cooling Sources - Chilled water vs. DX

- Chilled water usually preferred; cooling output is easier to control the water flow with a control valve.
- Direct expansion (DX) systems use refrigerant inside a cooling coil to cool and dehumidify the supply air.
- DX systems (compressors) can create dew point/humidity control challenges due to compressor cycling when temperature set points are achieved.
- If DX is necessary, the design engineer must understand the need for consistent supply air dew point control and specify equipment that alleviates the issue of compressor staging.

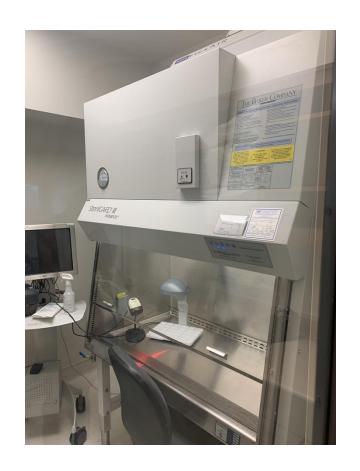
Impact of Equipment: Class II Type A2 vs. B2 BSC

- A2 cabinets recirculate 70% of their HEPA-filtered air back into the room and approximately 30% is exhausted.
- B2 cabinets require a hard-ducted building exhaust connection to draw the exhaust from the cabinet.
 100% exhausted.
- B2 cabinets require higher pressure exhaust systems, use more energy, costlier ductwork, operational challenges for maintaining room differential pressures.
- During facility downtime or device failure, entire room goes out of compliance and pressure reversals can be experienced

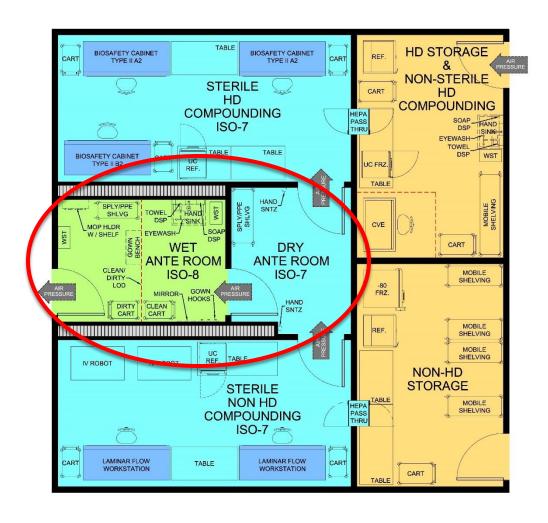
Package dx unit - 2 sets of refrigeration circuits - compressor

- Layout:
 - Single ante room vs.
 - Wet & dry ante room
 - Prevents incoming contaminants
 - Conflicting regulations, standards, and best practices do not always align for contamination control

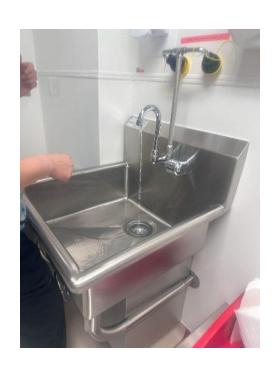
- Sink location –
- In single ante room design sink proximity; too close to HD room; shallow sink; proximity to PPE
- Integral eye wash
- Implement sink drain and p-trap cleaning program (No copper drain components – sporicides dissolve)
- HEPA ceiling filter location conflicts with PECs
- Proper placement of returns/exhaust especially in ante rooms... don't block!

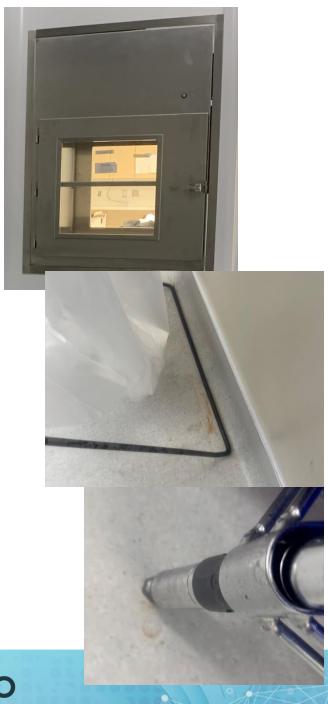
- Finishes: Walls, floors, ceiling, sealant
- Exhaust/return: blade style vs. egg-carton style
- Envelope and containment
- HEPA vs. non-HEPA powered pass-through between classified and non-classified spaces
- Furniture/Storage: examine grade of stainless (304 vs. 316)
- Recommend casters to prevent rust

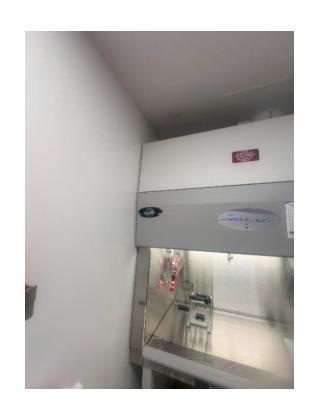
- Location of PEC
- Avoid installation of BSC adjacent to wall
- Avoid placement of BSC near doorways, pass-throughs
- Access panels lack of gasketing
- Ledges (e.g., ensure sloped top door openers, passthrough)

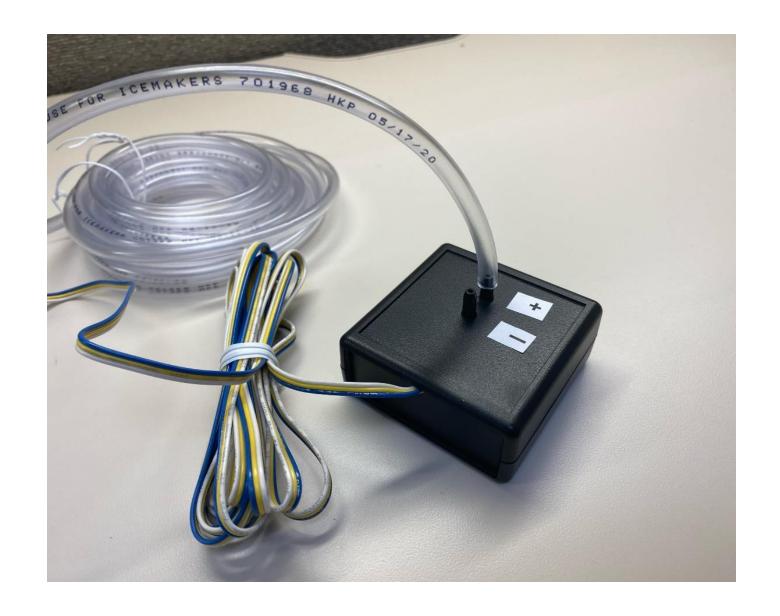
Case Study 1

- GMP biologics manufacturing program
- DP out of range and room certification failed
- No DP alarms had gone off

- Pressure sensor tube/valve malfunction
- No DP alarms → no alarms had been programmed
- Pressure sensor tube corrected and DP alarms set

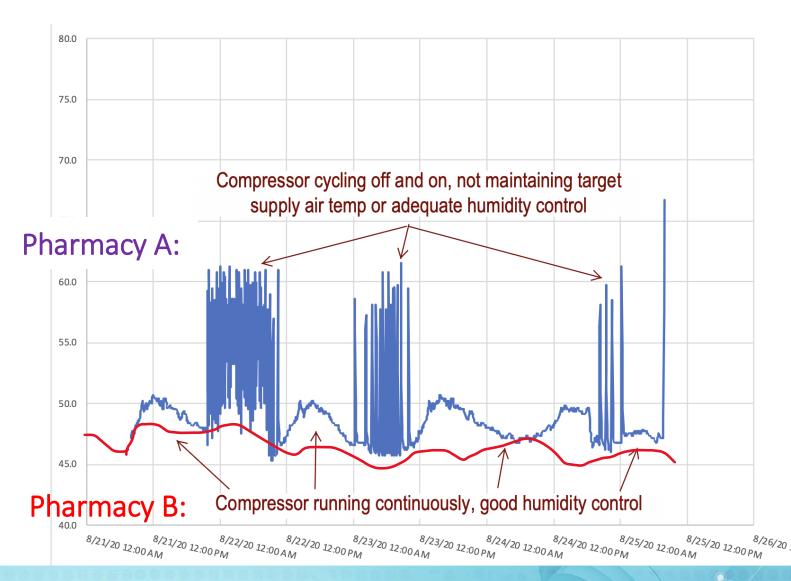
compressor cycles on and off – inadequate temp/RH control

Pharmacy B:

Compressor runs continuously

- Direct Expansion (Dx) Compressor Cycling
- Normal Dx unit has compressor that cycles on and off
- To overcome unit will need to be outfitted with hot gas bypass

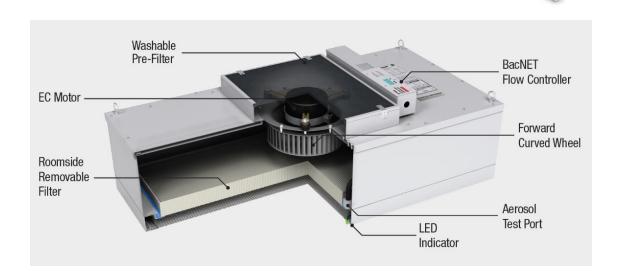
Fan Filter Unit (most

common)

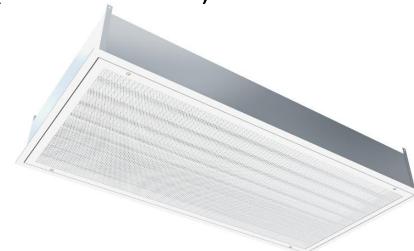
HEPA Filter Diffuser (uncommon)

With insufficient capacity from Dx AHU, the HEPA diffuser was not sufficient

- Hospital system recently renovated the oncology office building with a new small cleanroom suite containing 2 BSC, 1 LAFH, wet-dry ante room.
- Due to cost containment, the existing Dx unit servicing the office building was used for the cleanroom suite. The cleanrooms were installed using ceiling mounted HEPA filter diffusers
